## Report on Vibratory Stress Relief

Prepared by Bruce B. Klauba  
Product Group Manager

### VOITH SIEMENS York, Pennsylvania

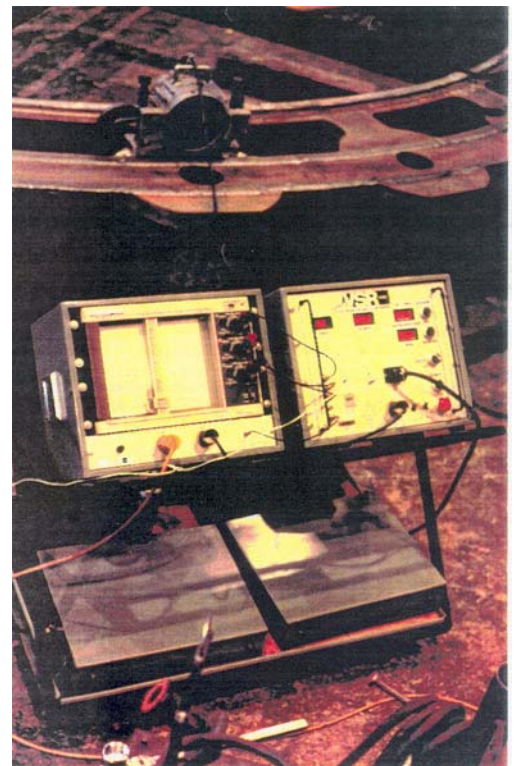
VSR setup. Three load cushions were used: one between the Vibrator and the Accelerometer; one midway along the arc of the workpiece, and the third at the far end, placed symmetrically opposite the one between the Vibrator and the Accelerometer.

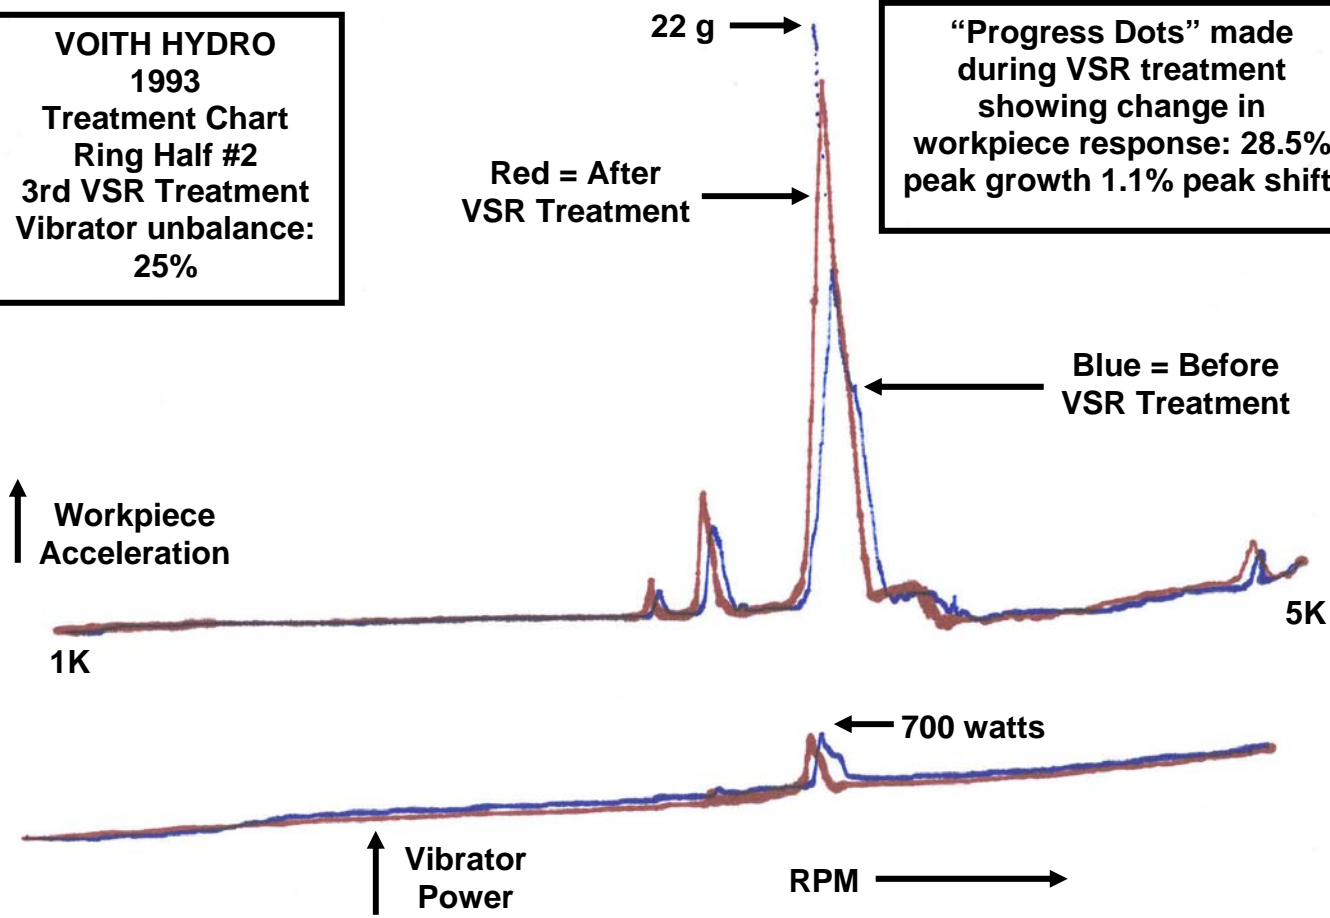
**VOITH HYDRO  
1993  
Treatment Chart  
Ring Half #2  
3rd VSR Treatment  
Vibrator unbalance:  
25%**

**"Progress Dots" made  
during VSR treatment  
showing change in  
workpiece response: 28.5%  
peak growth 1.1% peak shift.**

A Treatment Chart automatically generated by VSR 790A System. The Chart's upper pair of curves show workpiece response to vibration; the lower pair show Vibrator input power – both are plotted vs Vibrator RPM.

Pre-treatment data shown in blue; post-treatment in red. A Treatment consists of tuning to each of the blue peaks and then adjusting the vibrator speed – during growth or shifting of the resonance peak – until resonance pattern stability is achieved.

During Treatment of largest resonance peak, the pens were momentarily lowered once each minute. This made a pattern of blue marks ("progress dots") which document the progress of the resonance changes as growth and shifting take place. The lower dots are spaced far apart, which indicates rapid growth of the resonance peak; as these changes slow down (further up the peak), the dots are closer together, denoting less change. Further up the peak the dots begin to cluster meaning no additional

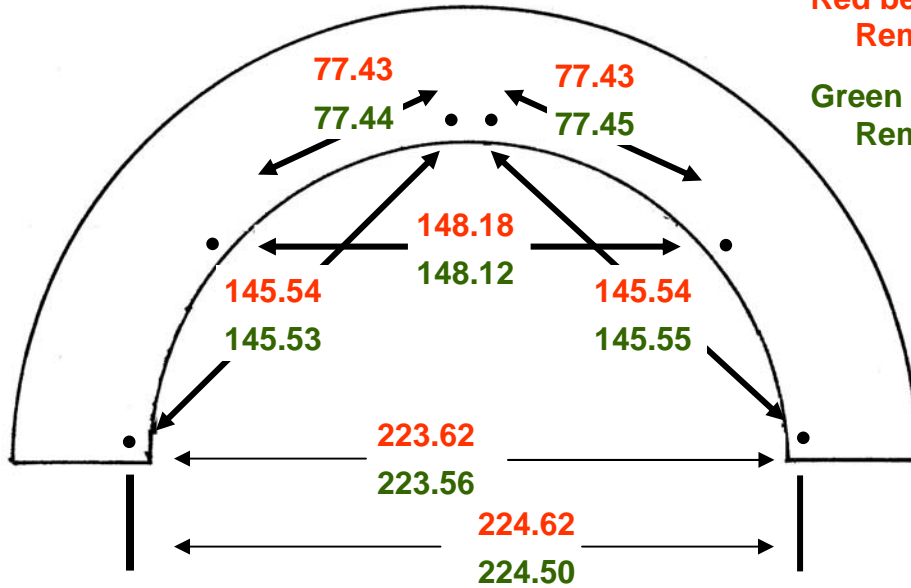
Sec in Bay 19N

Prior to brace removal, punch marks were placed at strategic points along the ID of each Half Ring, and measurements between the punch marks were recorded so that subsequent distortion could be measured and documented. The bracing was then cut away. The braces, which previously required two men with sledgehammers to knock out, simply fell to the floor. Distortion measurements on each of the Half Rings showed movement of  $<1/16$ " (most,  $< 1/32$ "). See Brace Removal Distortion Map (Page 8). In fact, machined reference points on the assembled Bottom Ring were monitored during the machining cycle, and showed movement of  $< 0.009$ ".
