## Report on Vibratory Stress Relief

### ALLVAC Monroe, NC

This Report describes using the VSR Process on a fabricated 20' dia. Inlet with Dome cover Assembly, made of 304 stainless steel. This Assembly was welded to a 28' dia. vacuum furnace. The fit between the Dome and Inlet flanges, responsible for the integrity of the furnace's seal, was a major concern to ALLVAC, and VSR TECHNOLOGY's Vibratory Metal Stabilization Process was chosen to stress relieve the Assembly prior to welding it to the furnace.

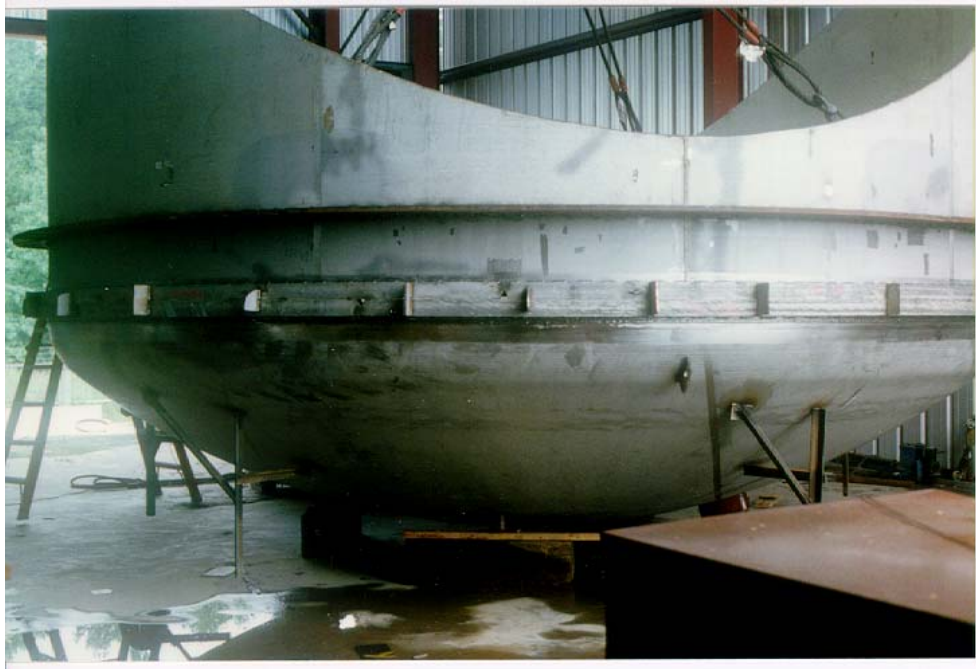
Photo 1

The vacuum vessel, fabricated of 304 stainless steel, consisted of a 28' dia. cylinder with a dome-shaped top and bottom (see Photo 1, pg 5). The Inlet Assembly was to be welded to the side of the vacuum vessel. The Inlet and its hinged Dome cover were being fabricated as a unit (back-to-back), with the Dome flange secured to the Inlet's flange. The mating surfaces would be sealed by an O-ring between them. (See Photos 3, 4 and 5, pg 6).

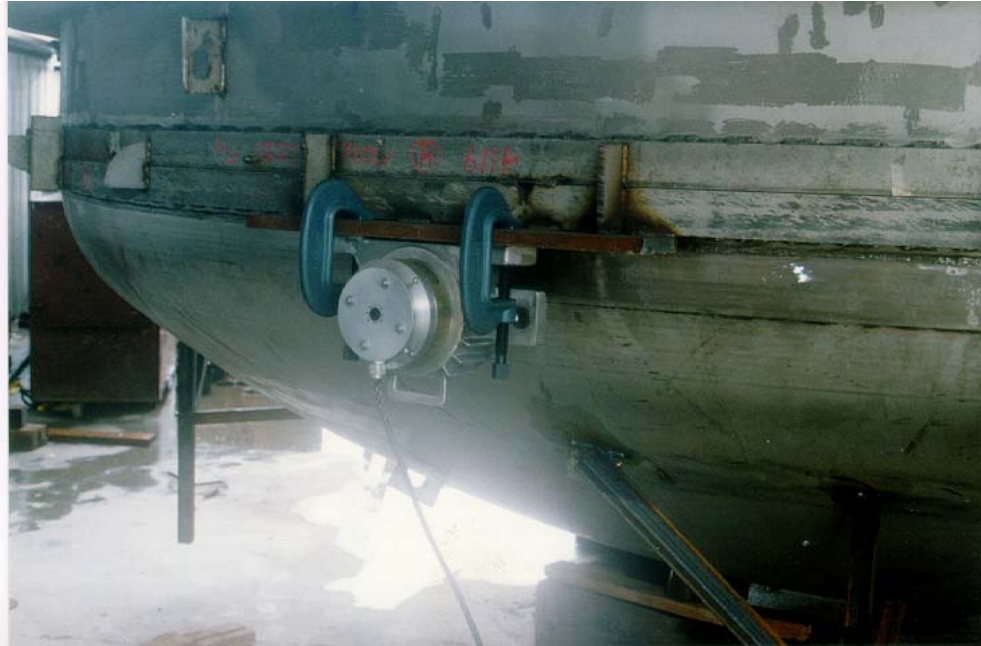
Photo 2

A Vibrator mounting flange was temporarily welded to the underside of the Dome flange (see Photo 2, pg 5). This attachment method permitted the most secure mounting of the Vibrator, so it could efficiently transfer its energy into the workpiece.

The location of the Vibrator mount (between the tallest portions of the Assembly), was chosen so as to maximize the responsiveness of the Assembly to vibration.
