## Report on Vibratory Stress Relief

Prepared by Bruce B. Klauba  
Product Group Manager

### TRI-ALLIANCE FABRICATING Mertztown, PA Job #1

TRI-ALLIANCE FABRICATING subcontracted VSR TECHNOLOGY to stress relieve a 28' x 8' x 1.5' mild steel, welded Trunnion Base. The workpiece fabrication consisted of two (2) heavy-walled, rigid, 28' beams joined by three (3) much lighter structural cross members.

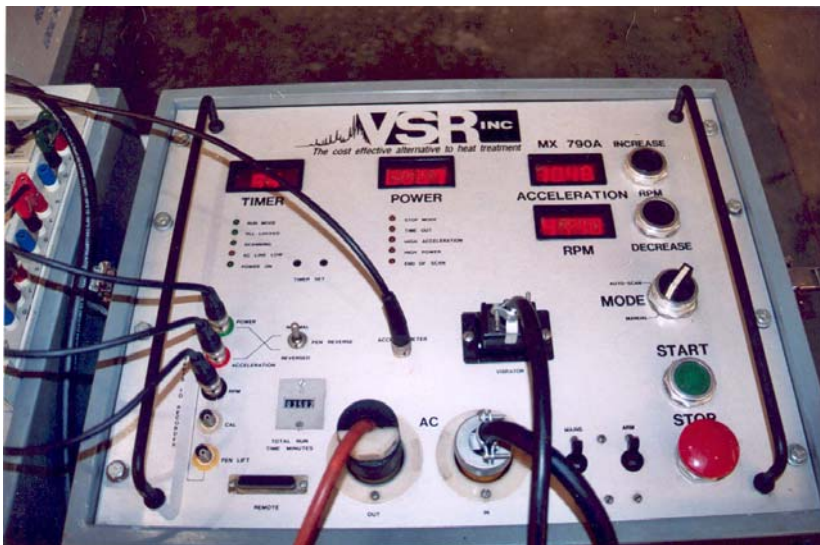
## PHOTO 5

**CLOSE-UP OF MX-790A CONTROL CONSOLE.** This unit contains the Vibrator motor drive, Accelerometer amplifier, plus the various controls and circuitry required to perform a Treatment. Note the acceleration display (upper right) reading 10.48g at 4140 RPM. This Photo was taken at the end of the Treatment performed on the large resonance peak during the 1st Treatment.

This “Rate of Change” phenomenon is exactly what occurred in this workpiece. Within 15 seconds of tuning upon the large peak, which occurred at a vibrator speed of  $\approx 4172$  RPM, the acceleration level grew  $\approx 10\%$  from 4.36g to 4.78g. This *growth* continued, although at a slower rate until it eventually stopped; additionally, a mild *shift* of  $\approx 32$  RPM also took place. The peak stabilized up 4140 RPM at a height of 10.48g (*as shown in Photo 5*).

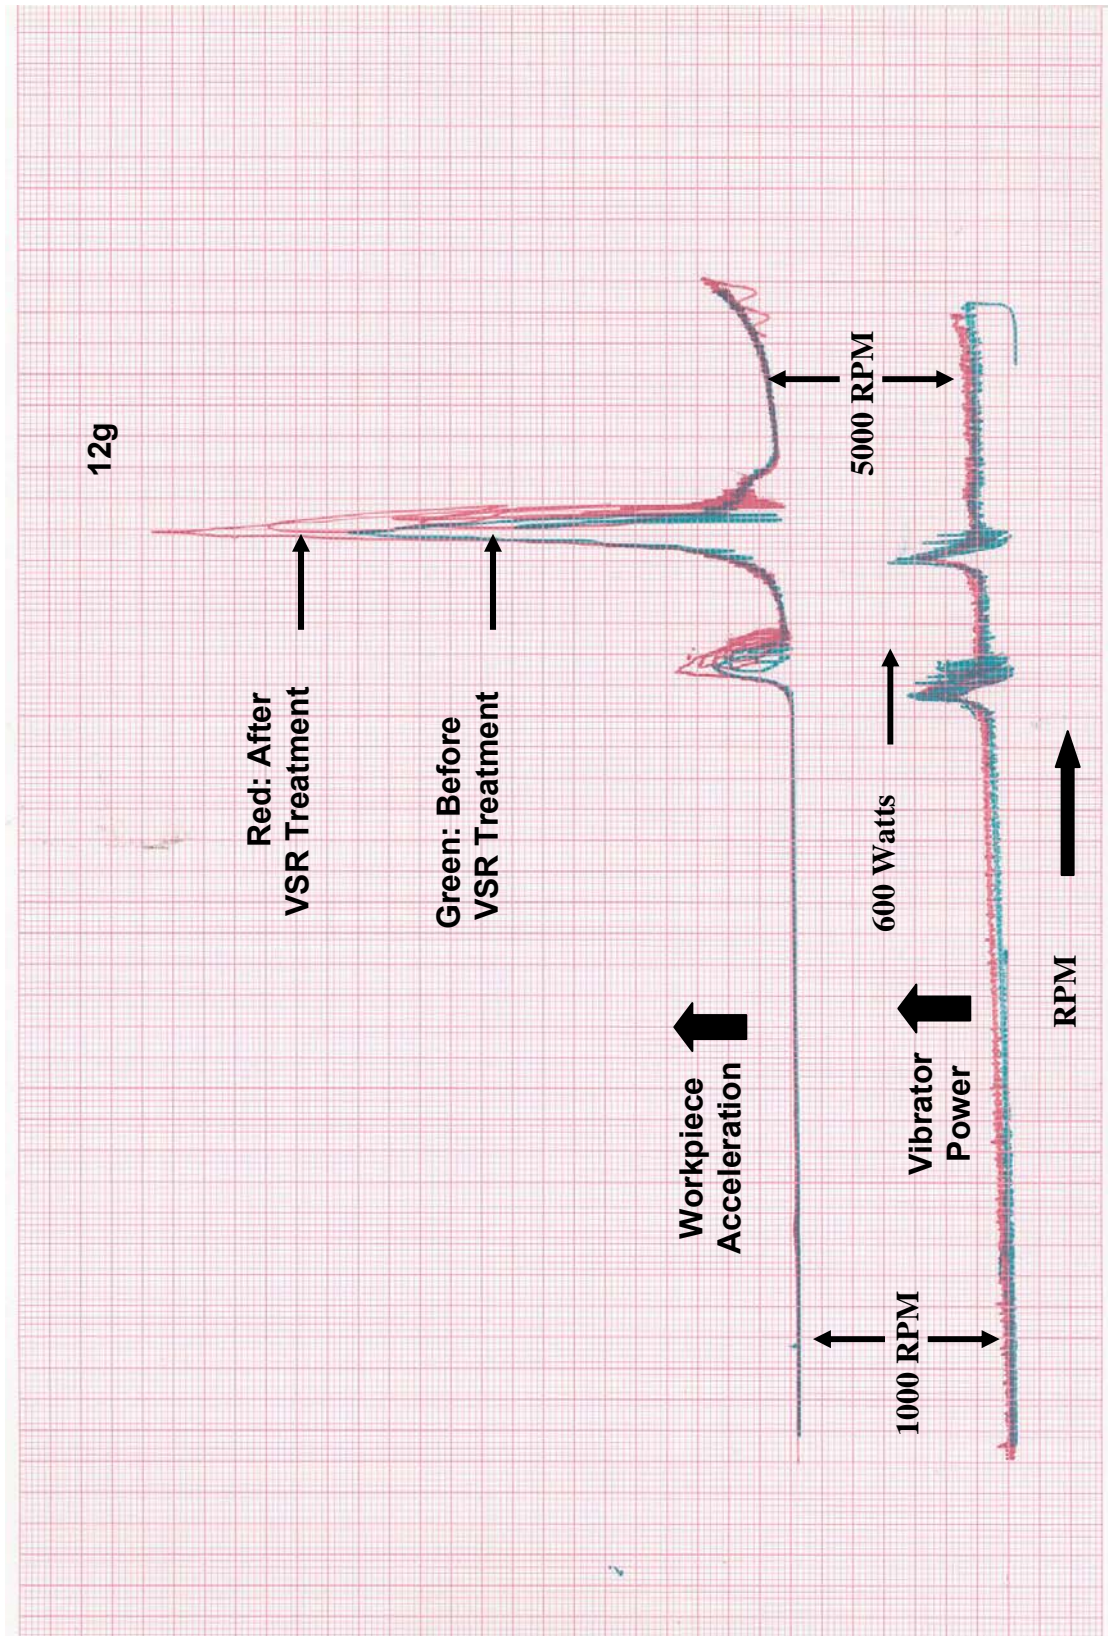
# 2nd VSR Treatment

The 2nd Treatment of the workpiece resulted in a slight, but still important, response. This response can be seen on the completed VSR Treatment Chart reproduced on page 10. Note that the growth of the resonance peaks during this 2nd Treatment was a mere 30%; compare this with the 1st Treatment’s growth from 4.36g to over 12g ( $>250\%$ ) – which was a very strong response.
