## Report on Vibratory Stress Relief

### **TRIALLIANCE FABRICATING: Mertztown, PA Job #2**

TRIALLIANCE FABRICATING, a steel fabricator, subcontracted VSR Technology to stress relieve a second mild steel, welded Trunnion Base. The workpiece was, 28' x 8' x 1.5' and consisted of 2 heavy-walled, rigid 28' beams joined by 3 much lighter structural cross members. A similar workpiece had been successfully threaded (based on dimensional stability during machining, and subsequent assembly and usage in January, 2004).

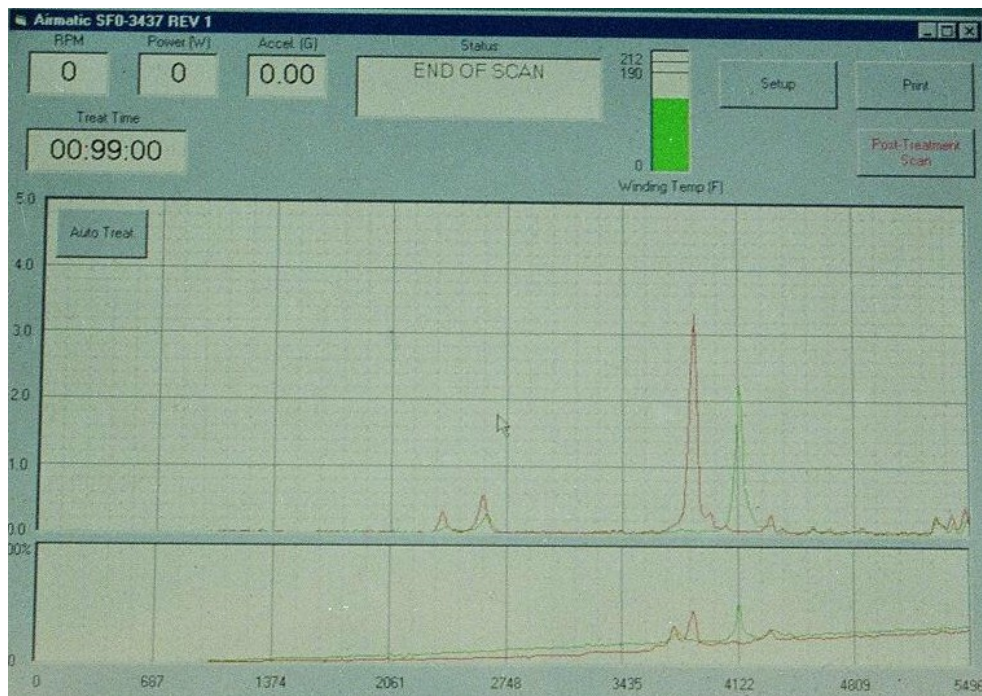
**Photo 4: SECOND TREATMENT Chart** To keep the power peak within limits, the vibrator was mounted in a different location on the second beam (close to a node of the large resonance). The power peak dropped from the 85% level (first treatment), to  $\approx 50\%$ , as shown. Again, note the growth and shifting of the large peak (the Pre-Treat recorded in green; Post-Treat in red). Less change took place in the smaller peaks, because they had been significantly stabilized by the first Treatment.

Based on the workpiece's unusual configuration, a second treatment was performed. This is because a workpiece consisting of two highly rigid sections (the 2 fabricated full-length beams), joined together by structural elements of much lower rigidity can allow independence to exist between the two rigid sections (the beams). Based on results, as shown by the system's instrumentation, the Trunnion Base did benefit. For the second treatment, the vibrator was moved to the opposite beam, and the Accelerometer was also moved to the opposite beam, so as to best detect signal from throughout the workpiece. (See Photo 4).
