Report on Vibratory Stress Relief

Prepared by Bruce B. Klauba
Product Group Manager

CAMERON COMPRESSION SYSTEM DIVISION

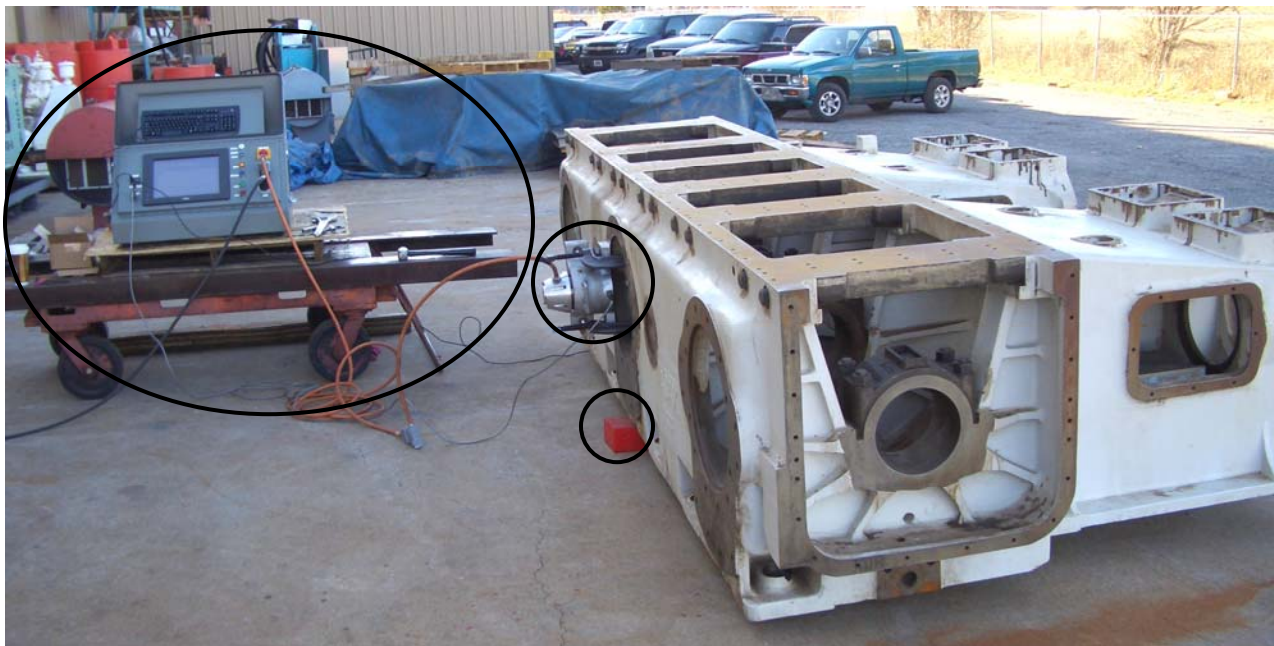
Figure 1: Compressor Frame setup for VSR Treatment. One Isolation Load Cushion (circled) is centered along continuous (non-gap) side of frame. The Vibrator (circled) was mounted above it. MX-8000 Console with touch-screen PC and USB keyboard visible on the left (circled).

Each Frame was placed on 3 Isolation Load Cushions. One Load Cushion was placed at the center of the long continuous (opposite the "gap") side, (*see Figure 1*). The other two Load Cushions were placed on the opposite long side, on either-side of the 20" gap (*see Figure 2*)

The Vibrator was clamped securely to the workpiece near the center of the "continuous" side (*as shown* Figure 1), and oriented so its Axis of Rotation (AOR) was horizontal, and parallel with the minor axis (width) of the workpiece. Other orientations were tried, but this orientation was found to generate both the greatest number and the highest intensity resonances, without causing peaks in the power curve – evidence that the Vibrator is well-positioned and oriented. An incorrectly located Vibrator or one adjusted to excessive unbalance results in large peaks in the power curve, which can trigger the VSR System's motor protection.

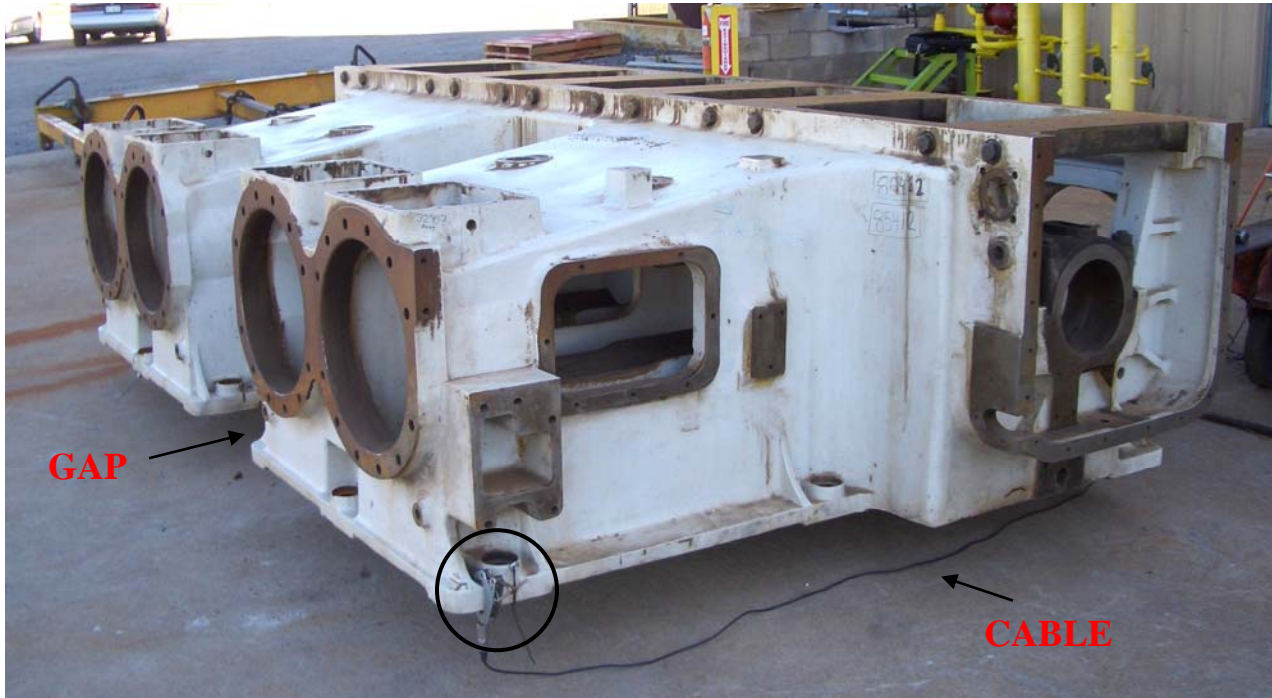
Figure 2: "Gap" side on left is ≈ 20 ". A Load Cushion was placed on each side of the gap (not visible), about 12" from the outer edge of the Frame. The Accelerometer can be seen in the foreground (circled), with its connecting cable leading to the VSR-8000 Console.

A second Treatment was performed, with the Accelerometer repositioned and reoriented. After testing a few different locations and orientations, an ideal Accelerometer location was found directly above the one shown in Figure 2, and the sensor was oriented so as to be sensitive to amplitude in the direction of the workpiece's major axis (length of workpiece). This new positioning yielded better resonance data for the higher RPM resonance frequencies located at 5000, 5600, and 5800-RPM (*see Figure 5*). Note that the large resonance shown in Figures 3 & 4 is much shorter in Figure 5.

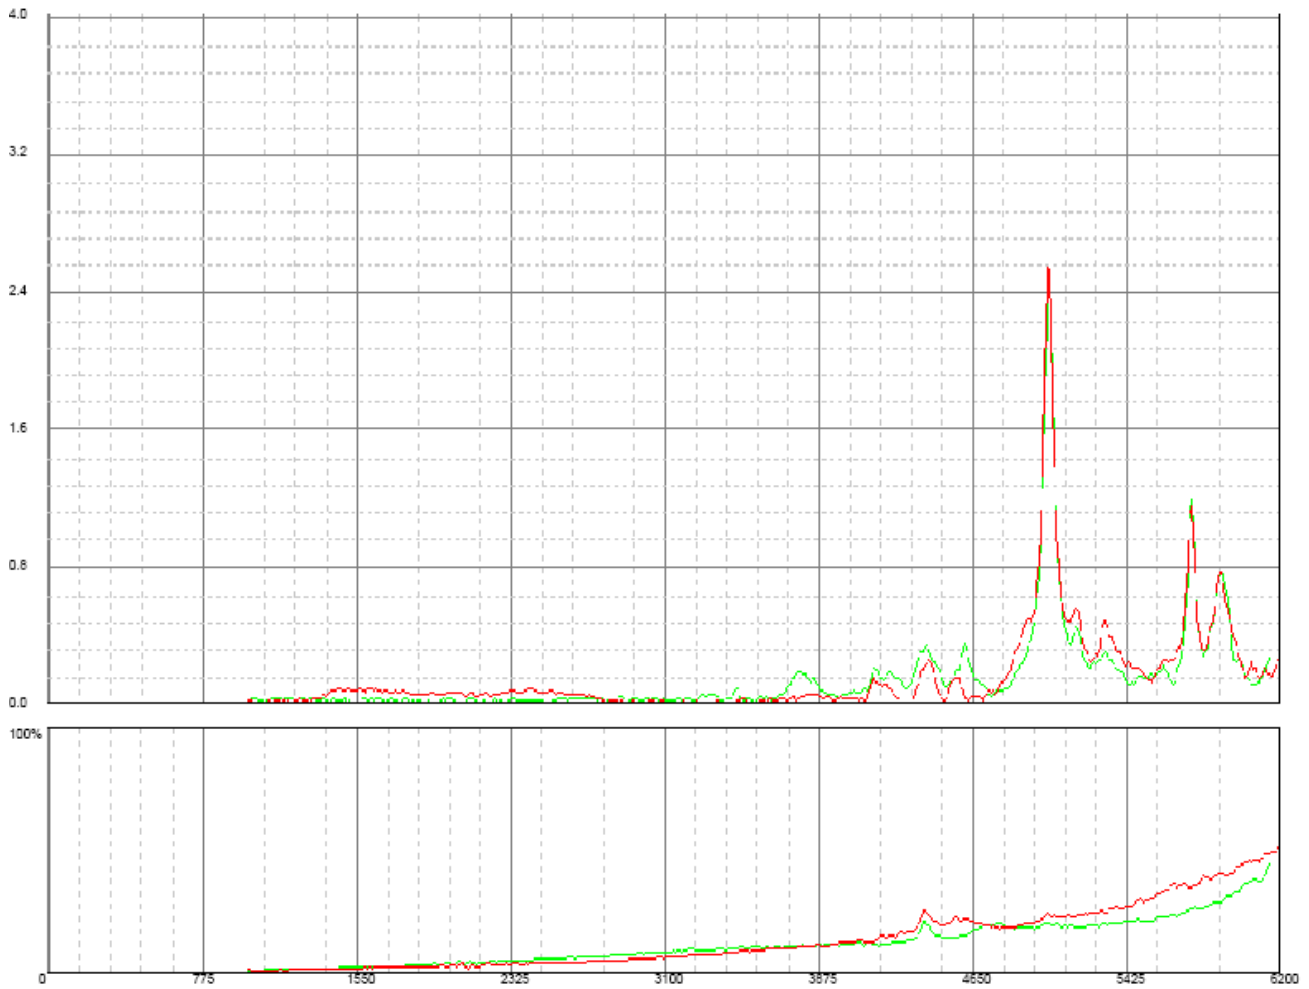
Figure 5: Workpiece 1, Treatment 2. Relocation and re-orientation of the Accelerometer enabled high RPM peaks to be easily detected. However, little peak growth or shift took place, as evidenced by the similar Pre- and Post-Treatment Scans.
