## Report on Vibratory Stress Relief

**9500 HP FAN HOUSINGS**

Large distortion during separation of 9500 HP Fan Housing halves led a large fabrication shop to explore the VSR Process as an alternative to heat straightening. The results obtained using the VSR-8000 System were significant: a  $\approx 90\%$  reduction in the distortion that had plagued CND in the past.

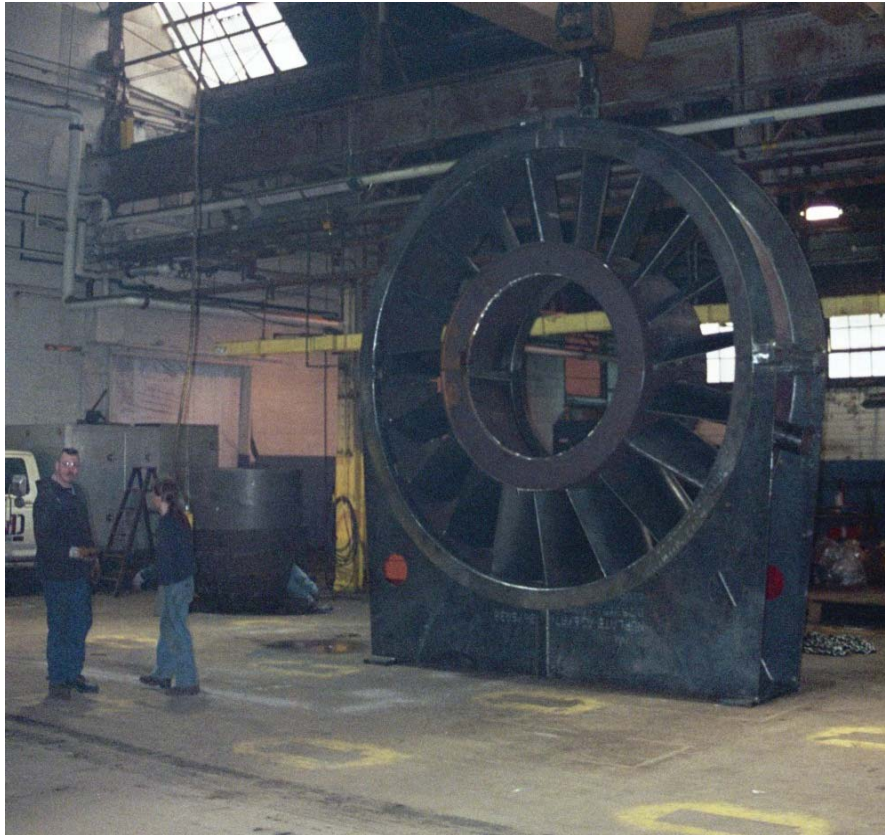
**Figure 1:**

**9500 HP FAN HOUSING WELDMENT.** The split-line runs horizontally through the center. This fabrication technique is called "back-to-back" fabrication since each weldment section acts as a fixture to reinforce the other.

CND INCORPORATED, Massillon, OH, is a large-scale fabrication shop producing 9500 HP Fan Housings for a TLT BABCOCK for use in large-scale cooling and ventilation applications. A Fan Housing consists of two halves (upper and lower w/base); the halves are mild steel weldments and the assembled unit measures 197"H X 179"W X 43"D, and weighs 17,000 lbs. The Housing fabrication is made using the "back-to-back" fabrication method, in which the two halves are temporarily held together during fabrication with welded steel plates spanning the split-line between them. The assembled Fan Housing weldment is shown in Figure 1.

The problem CND needed to address was the distortion that took place after all welding was completed, and the two halves were separated. Separation is done by arc-torch cutting of the welds of the "spanning plates", which join the two halves. Distortion was manifested in two forms:

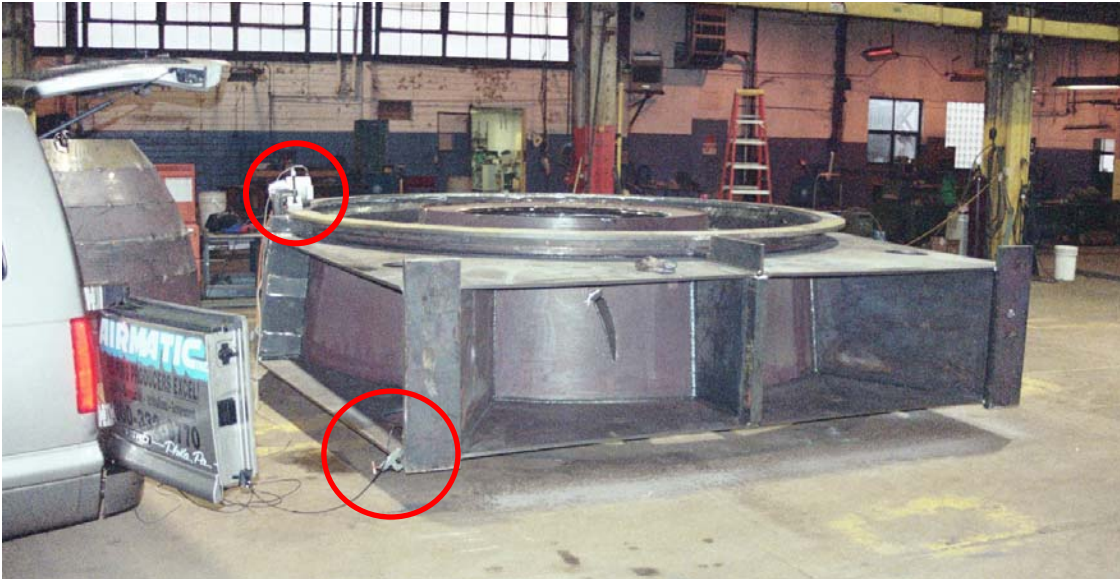
**Figure 3: VSR SETUP.** Weldment lowered to be aligned with horizontal plane (to minimize damping), and placed on 3 Isolation Load Cushions (not visible) located immediately underneath the flange ID. The Vibrator (circled) is attached to the top flange. Accelerometer (circled) is clamped to base of workpiece, and oriented to be most sensitive to vertical deflection of workpiece during vibration.

1. Positioning the workpiece so that it was "lying down", ie, greatest ground contact in the horizontal plane.
2. Placing three Isolation Load Cushions (each 10"L X 6"W X 4"H) beneath the inner flange surface, just inside the Fan Housing's ID.
3. Locating the Vibrator on the outer flange, on the "base-side" of the split line. The Vibrator was oriented so that its Axis-of-Rotation (AOR) was horizontal, and directed through the workpiece's axial center.
4. Locating the System's Accelerometer on the base of the workpiece, oriented so as to be most sensitive to vertical deflection.

A photo of the VSR Setup can be seen in Figure 3.

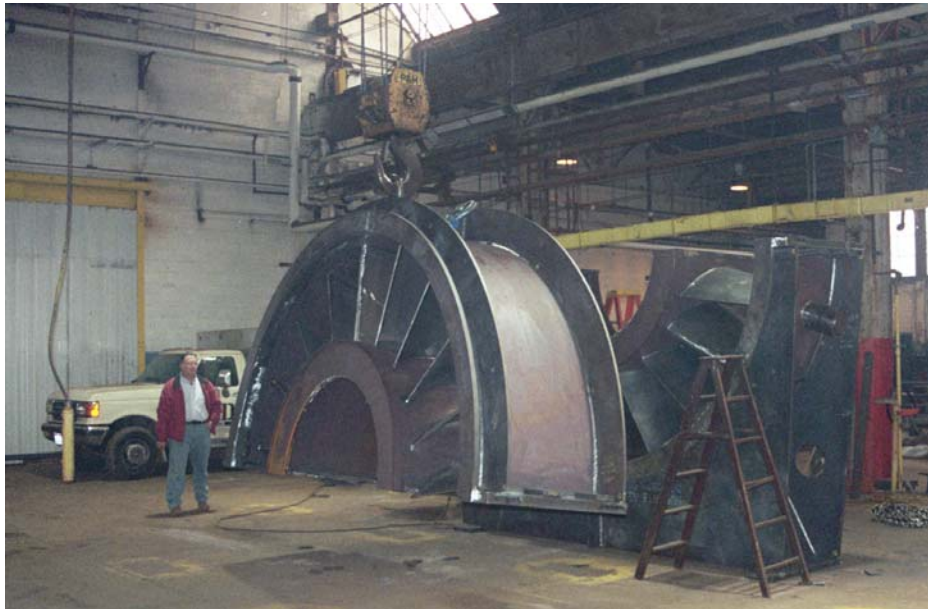
**Figure 10: Fan Housing's upper half was lifted from the lower half during separation.**

Upon removal of all the spanning plates, the vertical separation between the two halves was 1/8" to 3/16" (worst case). Axial distortion was similar:  $\approx 1/8"$ . This reduction represented a five-fold decrease in the distortion, and lead CND to the following conclusions:

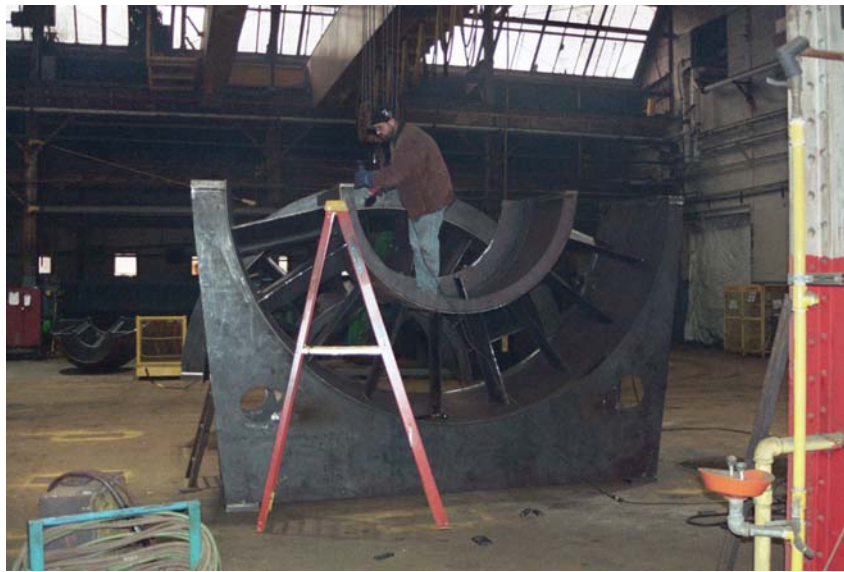
**Figure 11: Arc-torch cut marks were ground smooth.**

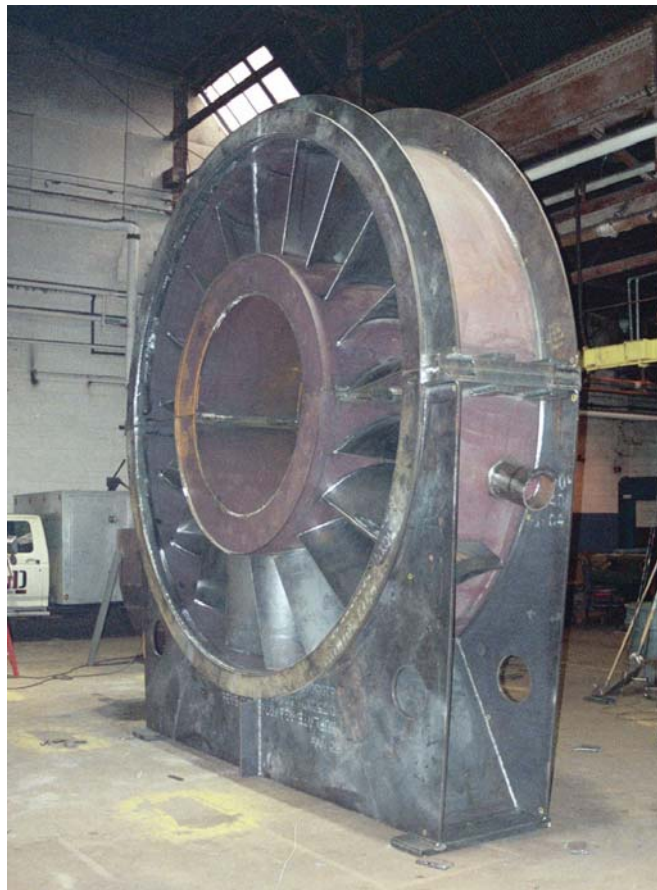
**Figure 12: Fan Housing, reassembled with minimal misalignment, awaiting transport to machine shop.**
