## Report on Vibratory Stress Relief

Prepared by Bruce B. Klauba  
Product Group Manager

### VOITH SIEMENS York, Pennsylvania

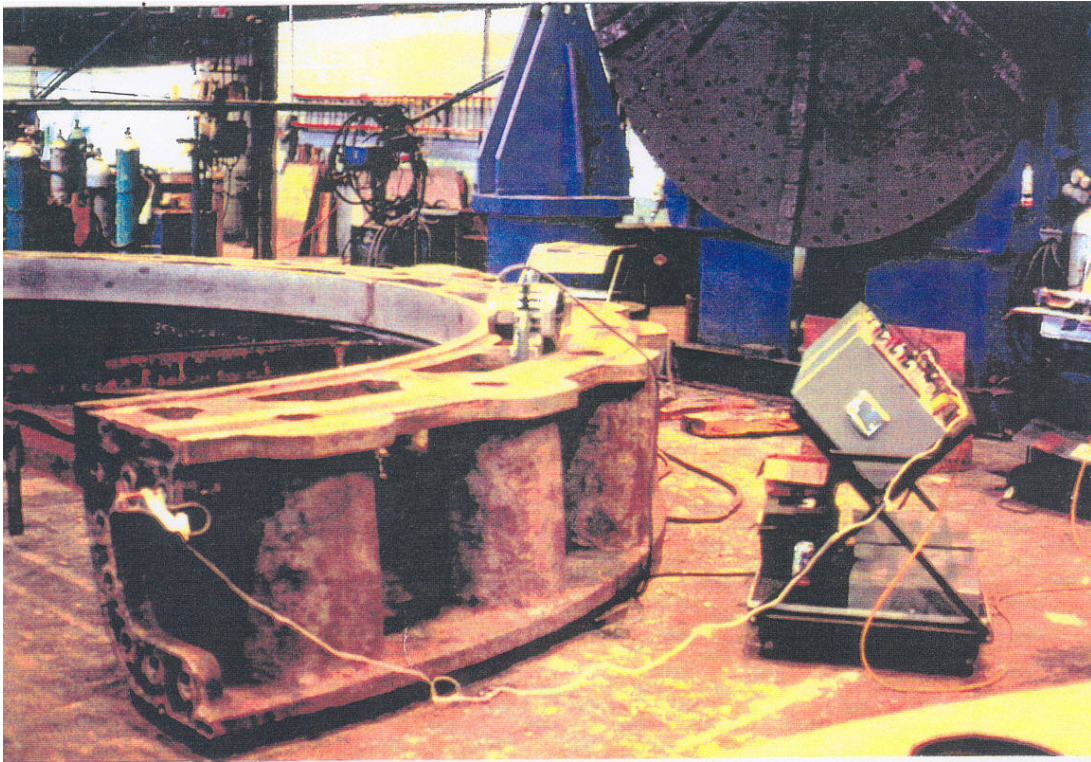
VSR setup. Three load cushions were used: one between the Vibrator and the Accelerometer; one midway along the arc of the workpiece, and the third at the far end, placed symmetrically opposite the one between the Vibrator and the Accelerometer.
