## **Report on Vibratory Stress Relief**

Prepared by Bruce B. Klauba  
Product Group Manager

### **INGERSOLL MACHINE TOOLS INC Rockford, IL CROSS RAILS JOB**

INGERSOLL, a manufacturer of special machine tools, is a regular user of the VSR Process. This Report describes the successful use of the VSR System on the Cross-Rail member of a Gantry-style Milling Machine.

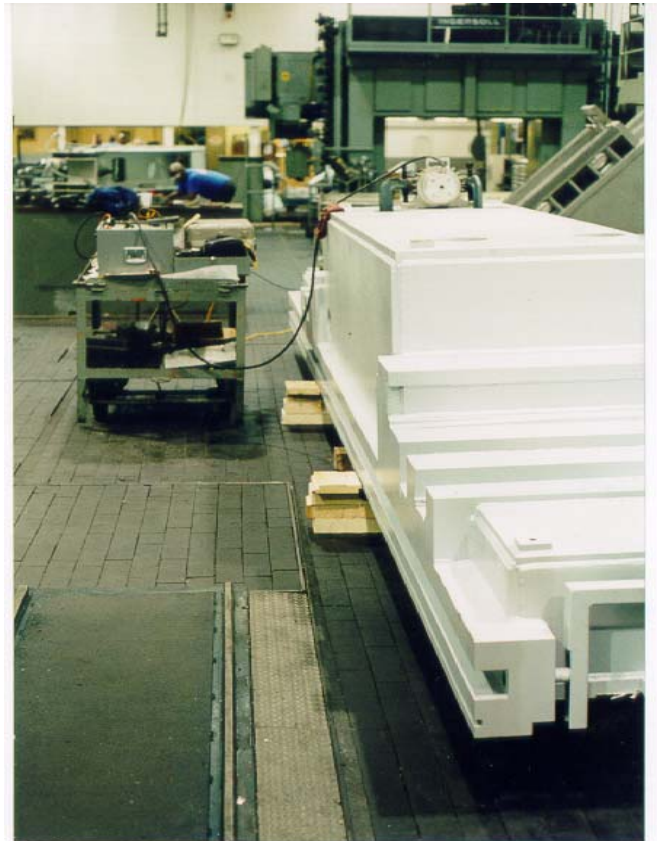
### Photo 3

**Cross-Rail setup for VSR Treatment. Two (of the three) Isolation Load Cushions were placed on top of wood planks used to support and level the workpiece. The third Load Cushion (not shown) is centered on the opposite side. The Vibrator, mounted securely to the workpiece over one of the Load Cushions, has its axis of rotation oriented parallel to the length (X-axis) of the workpiece, so as to drive the workpiece in the directions it can resonate.**

*As shown* in Photo 3, page 9, the workpiece was placed on three (3) Isolation Load Cushions which were placed far in from its corners, so as to minimize damping. This placement allows not only the greatest number of resonance peaks to be generated, but also the largest amplitude of those peaks, which enhance the effectiveness of the Vibratory Treatment. Due to the contour variations of the underside of the workpiece, rigid wood planks were needed under two of the Load Cushions to keep the Cross-Rail level. In Photo 3, page 9, these two wood planks can be seen at two points along the length of the workpiece, each 1/3rd in from its end. The third Load Cushion, was located on the opposite side, centered along the workpiece's length as shown in Photo 4, page 9.

The VSR System's MV1 Vibrator (visible on top of the workpiece in both photos on page 10), was securely clamped to the workpiece above one of the Load Cushions on the nearside, and oriented so the its axis of rotation was parallel to the length of the Workpiece. This Vibrator orientation was chosen so as to excite the workpiece in the directions it would most likely resonate, specifically, the two directions perpendicular to the length of the workpiece. If the length of the workpiece is considered to be the X-axis, the width, the Y-axis, and the height, the Z-axis, the workpiece would most likely resonate in the YZ plane. The location of the Vibrator was chosen because it was likely to be near one of the *nodes* of the workpiece. Nodes are those locations, typically “lines” in 3 dimensional structures, that undergo minimal movement during resonance. Nodes are good locations to place the Vibrator for two reasons: (1) The clarity of the data generated during a VSR Treatment will be enhanced; (2) As the most dynamically rigid mounting location, we can not only cause better vibration transmission but also extend the longevity of the Vibrator.

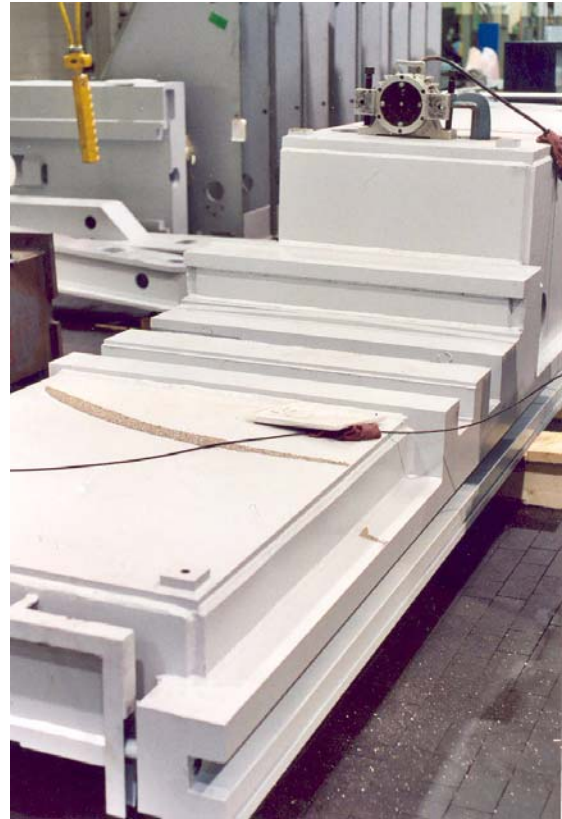
## Photos 5 & 6

Resonance is distinguished not only by producing peaks in the acceleration (and force) that a workpiece experiences, but also by producing a clearly defined Nodal pattern of high and low (virtually zero) amplitude on the workpiece. This is sometimes referred to as a *standing wave*, since the nodal wave pattern on the workpiece is stationary.

Shown here is the nodal pattern produced on the Cross-Rail. Photo 5 shows the end of the workpiece where the Vibrator is mounted, while Photo 6 shows the opposite end. Oil Dry, which had been sprinkled on the top of the workpiece, was driven off the high amplitude locations, and settled on the low amplitude locations. These are the *nodes*. These node areas are good locations for mounting the Vibrator and installing the Load Cushions, they are not, however, suitable areas for attaching the Accelerometer.

**NB:** The nodes generated on a VSR workpiece can often be seen by sprinkling a dry powder, *eg*, Oil Dry, on the workpiece during resonating. The powder gathers on the nodes because it is driven from those areas undergoing high amplitude. Photos 5 and 6, page 10, show some of the nodes generated on the Cross-Rail. As can be seen, the Vibrator was relatively close to one of the nodes.
